RANS

Airworthiness Directive: 135
Date: September 25, 2007
Subject: CAB-TANG Failure
Compliance: Mandatory
Models Affected: All RANS aircraft with cable braced tails.
(S-4, S-5, S-6ES, S-6S, S-7, S-9, S-10, S-12, S-12XL, S-12S, S-14, S-17, S-18)

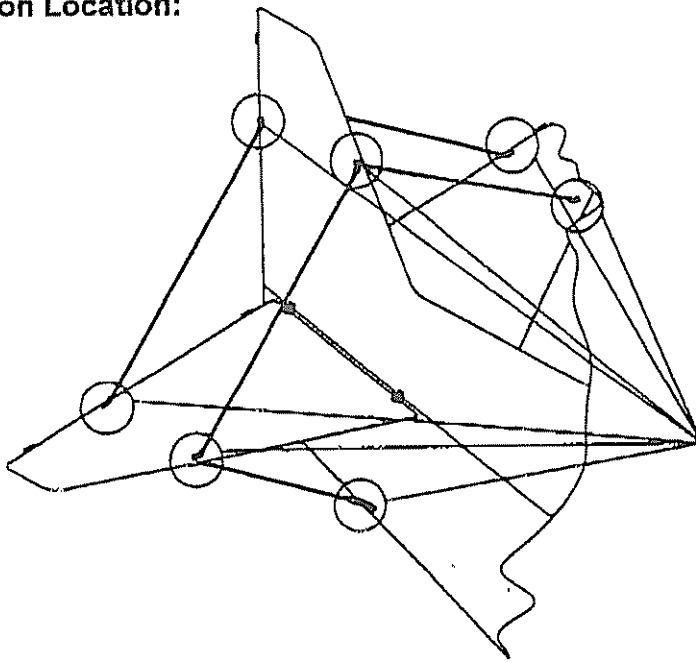
Inspection Location:

It has been brought to our attention that failures have occurred in the tangs at the ends of our tail brace cables. Some possible causes for this are:

1. Improper bending or re-bending of the tang during installation.
2. Improper tension of the cable resulting in vibration.
3. Pushing or pulling the cables during ground handling.

INSPECT ALL TAIL
CABLES AND TANGS

Inspect before next flight. If cracks or defects are found, remove the aircraft from service until it is possible to replace the cable assembly with latest revision.

- Option 1 - Inspect all cables at 50 hour intervals and at condition inspection. Replace if cracks or defects are found.
- Option 2 - Replace cable with latest revision and inspect at condition inspection. Contact RANS Parts Department for replacement parts.

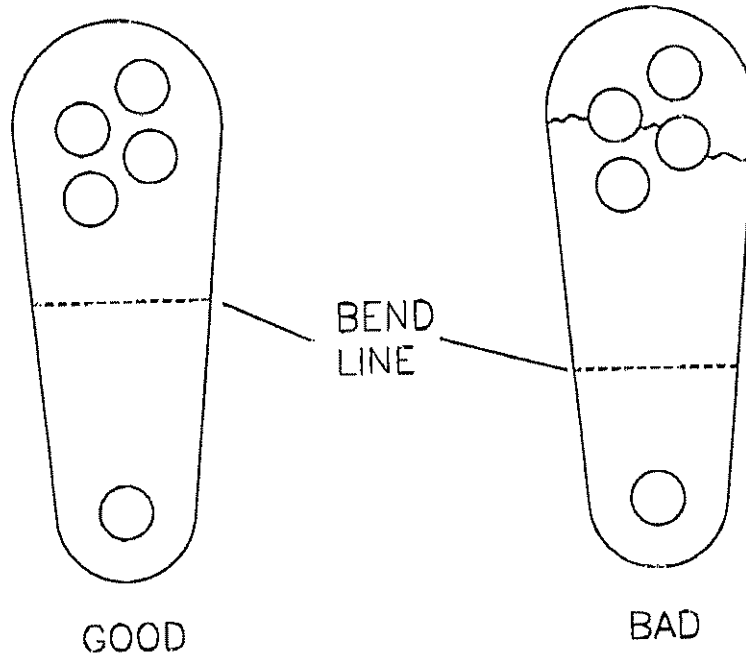
Inspection Procedure:

Remove bolts holding the CAB-TANG and inspect the tangs using a 10X magnifier.
